Sinclair Wash Restoration Feasibility Study Final Presentation

CENE 486 April 24, 2020 Hyd Engineering Team Eric Lima, Xiaolei Wang, Saud Bohasan

# 1.0 Project Introduction

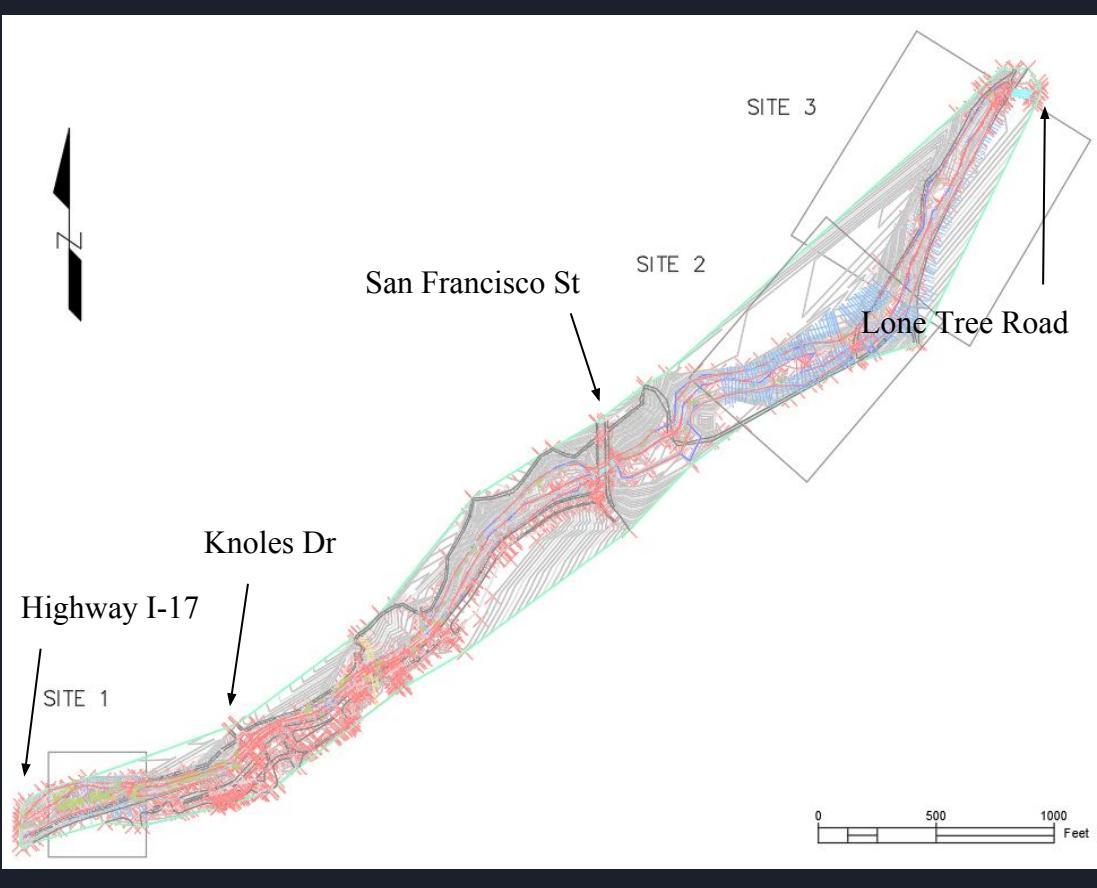
- Using the previous teams topographic models and hydraulic models as base point of study.
- Civil 3D determine the low points, path of thalweg.

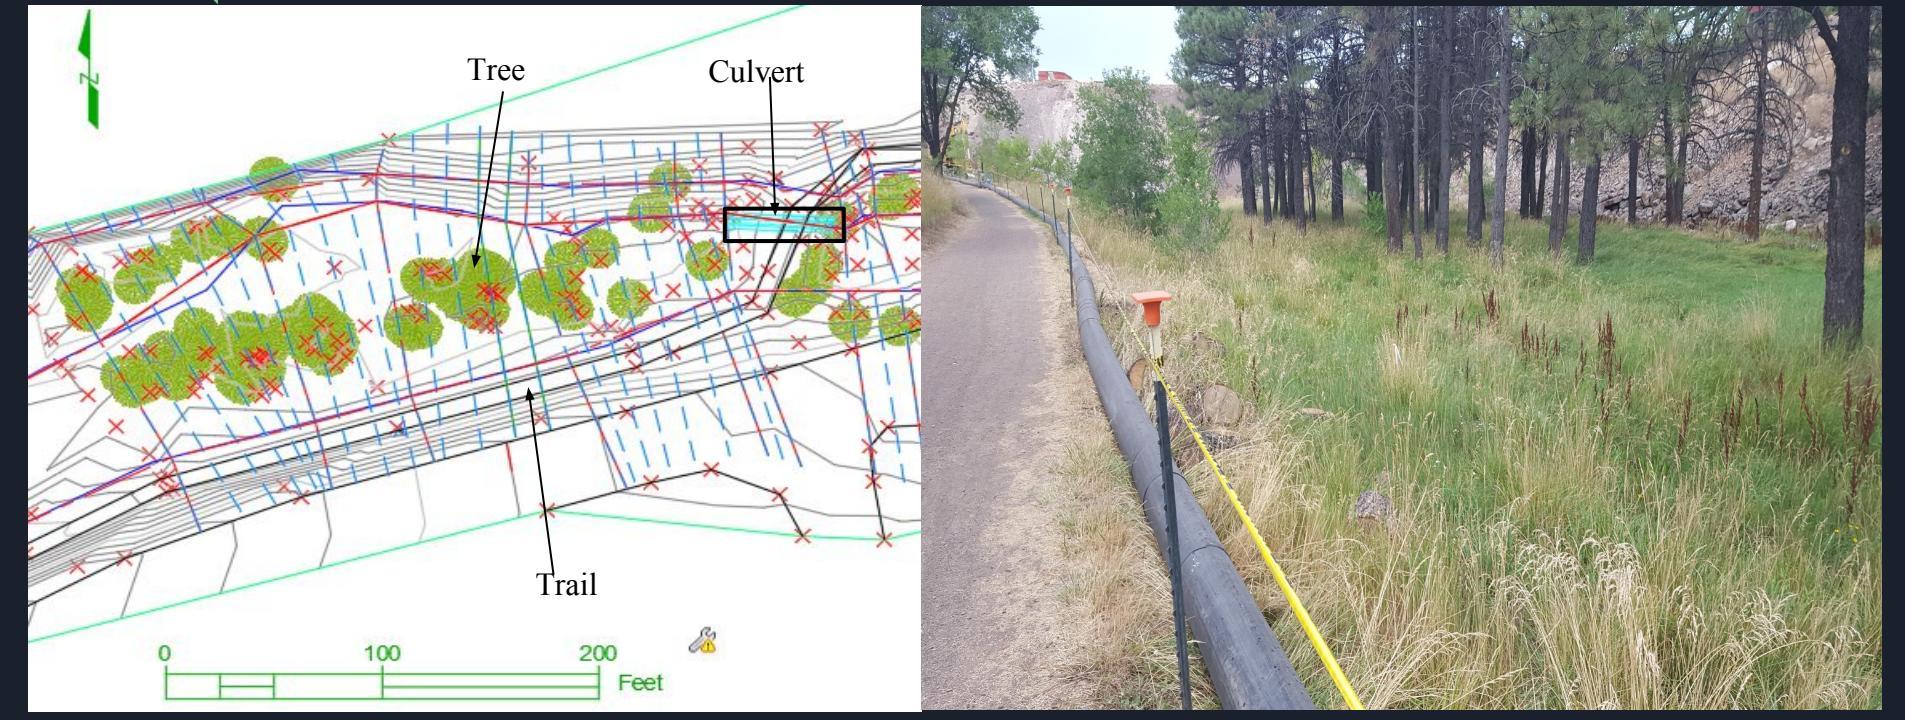
Fig. 3 - AutoCAD Drawing of Site 1.

Lots of trees and low points within the site

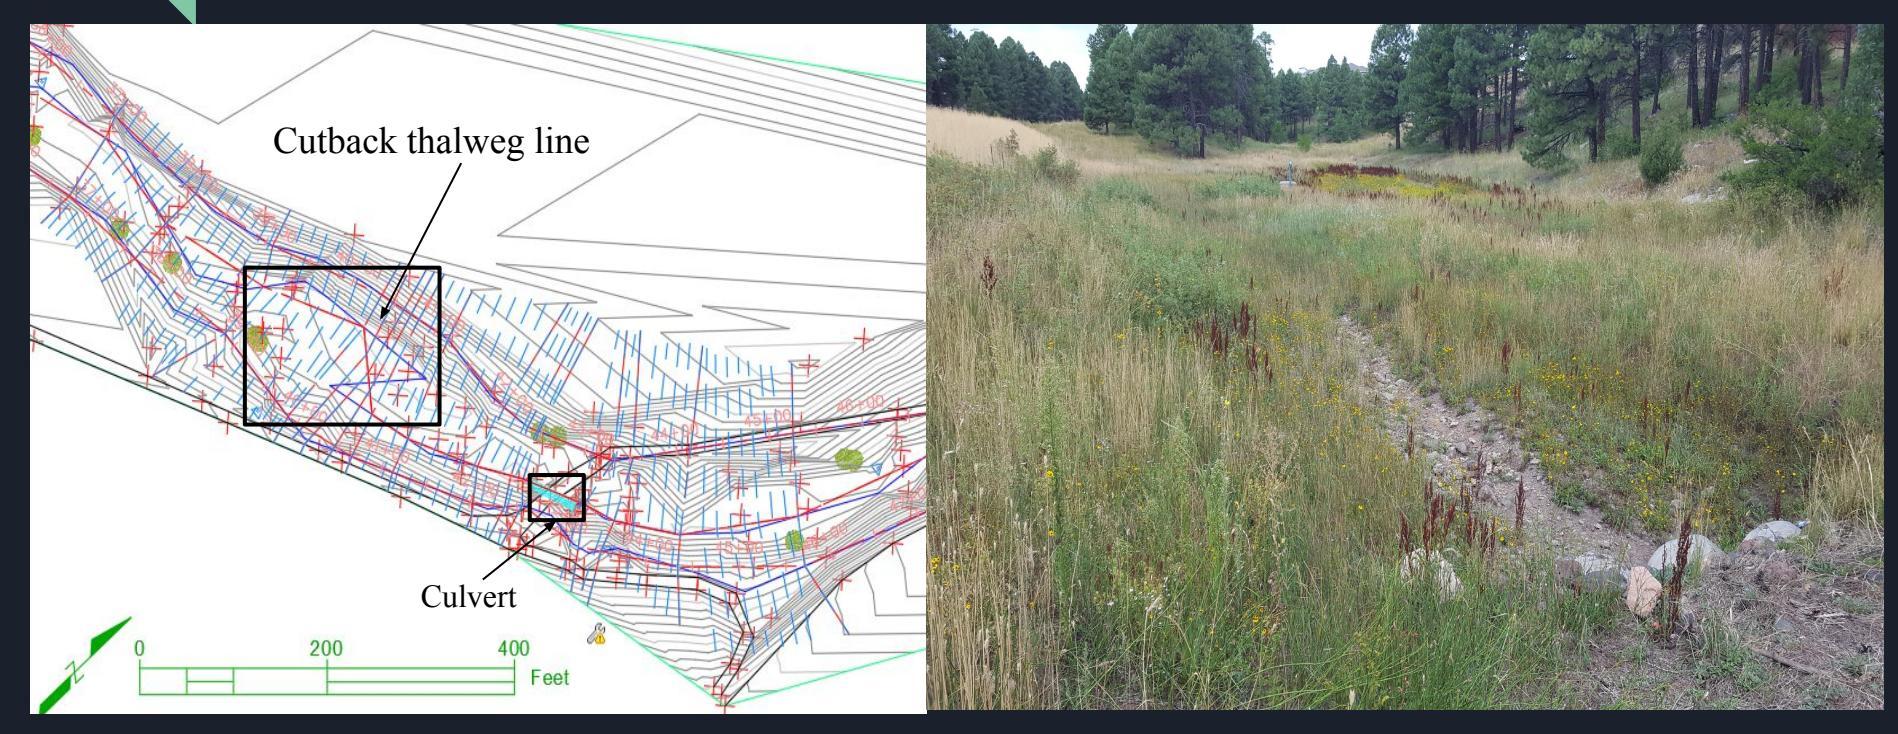
Cutback in thalweg line and lots vegetation problem

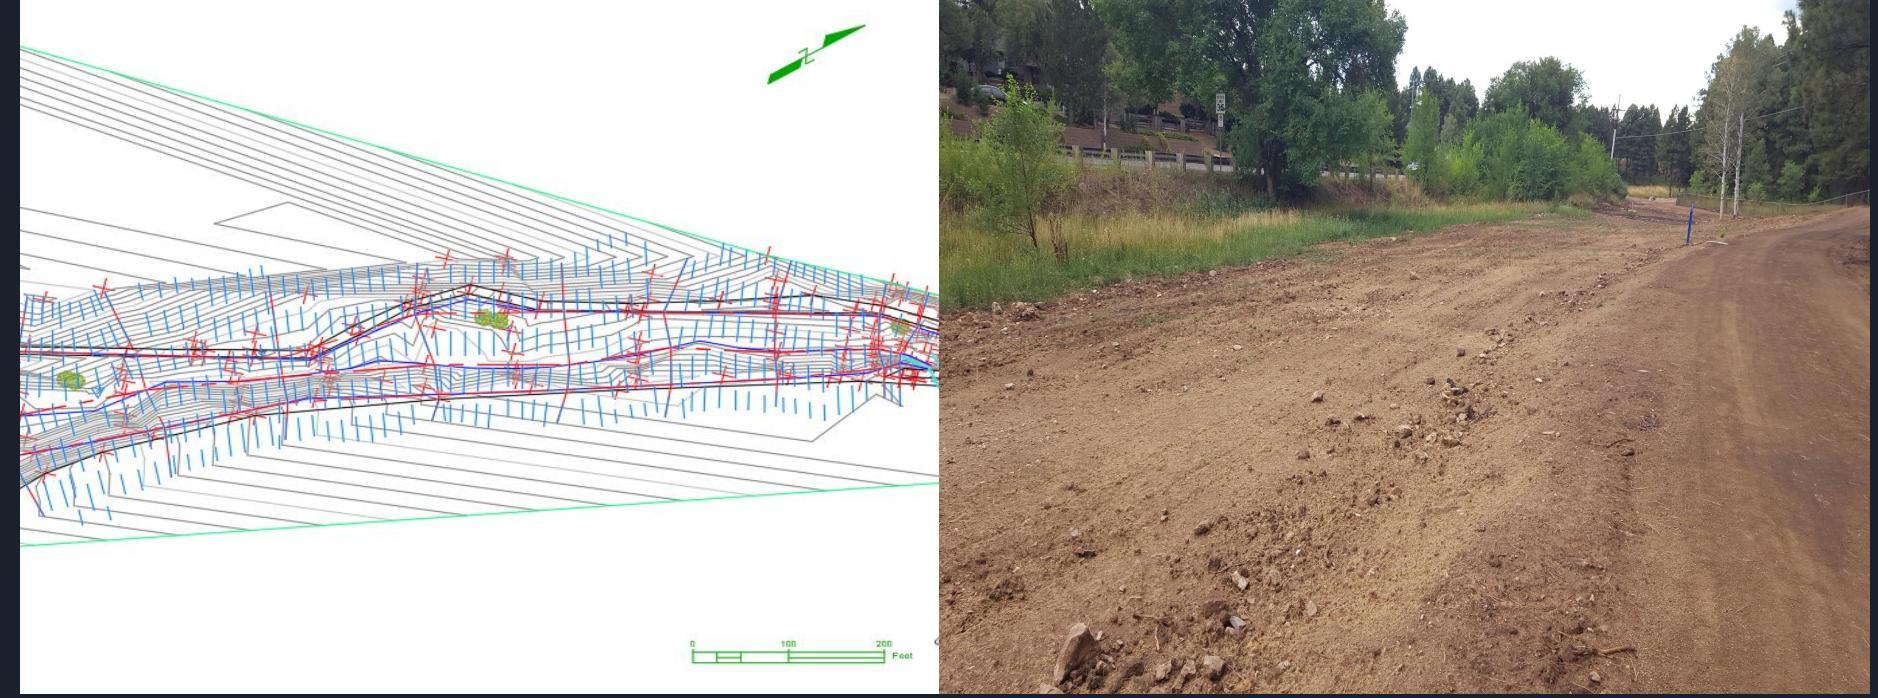
Fig. 8 - Field image for Site 3.

The channel lining to be replaced with dirt and gravel

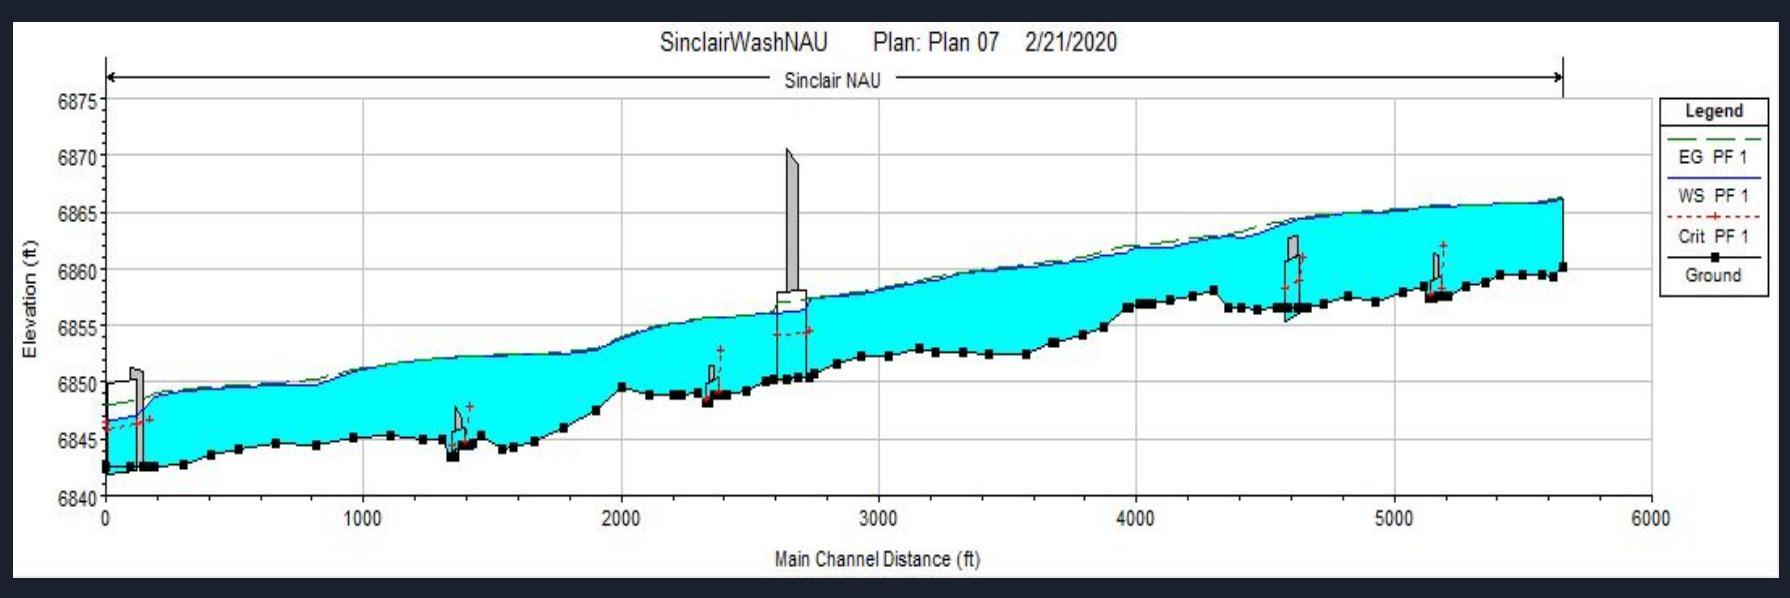
Fig. 9 - Liszewski's 100 yr flood profile [1].

- ◆ Account for San Francisco Street Culvert and Knolls Drive
- Rating table made to account for the changes in flow.

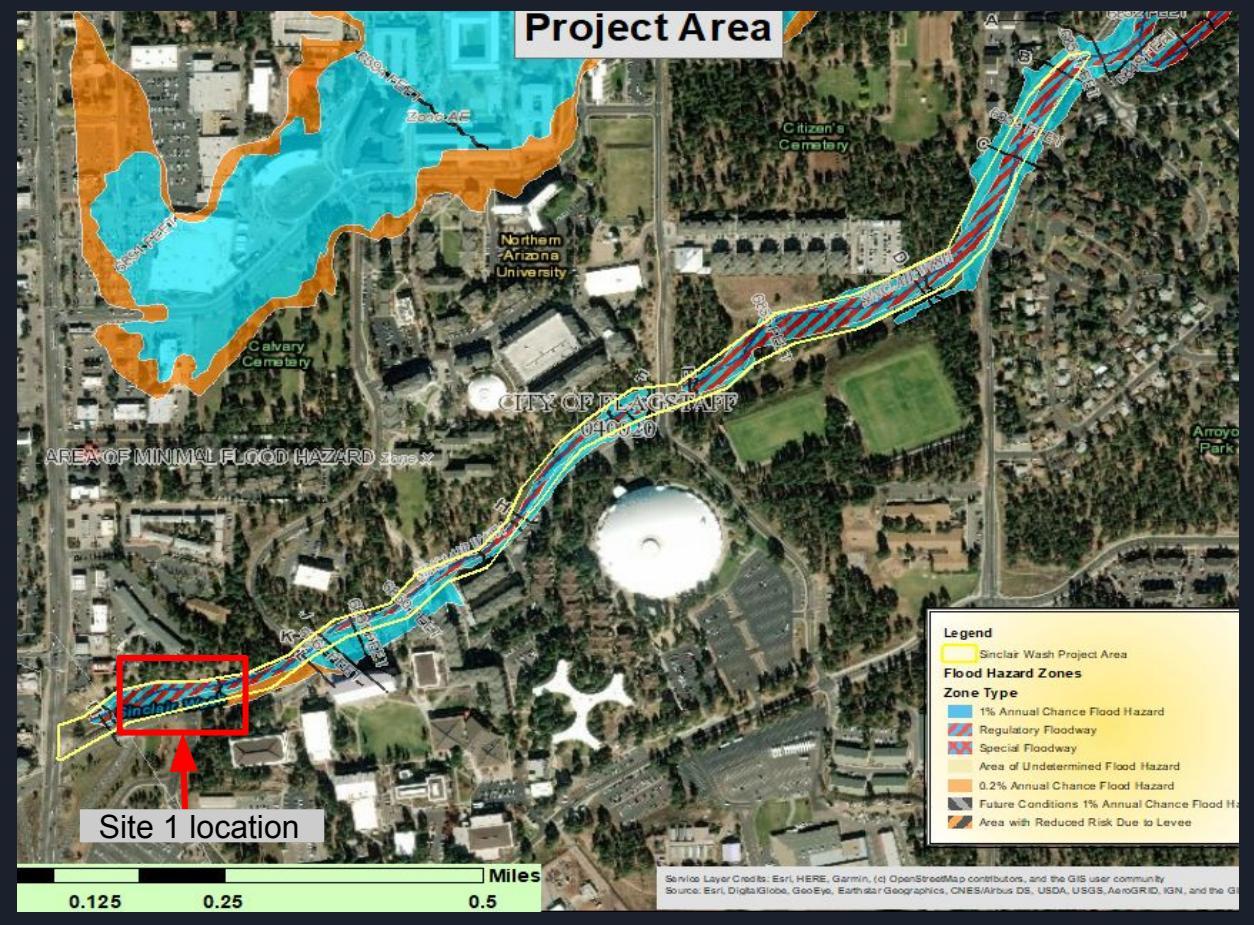
Fig. 13 - Overview of Site 1.

- Remove trees in channel
- Remove overgrown grasses
- Remove culvert at
   Flagstaff Urban Trail
   Crossing
- Remove invasive species in the area

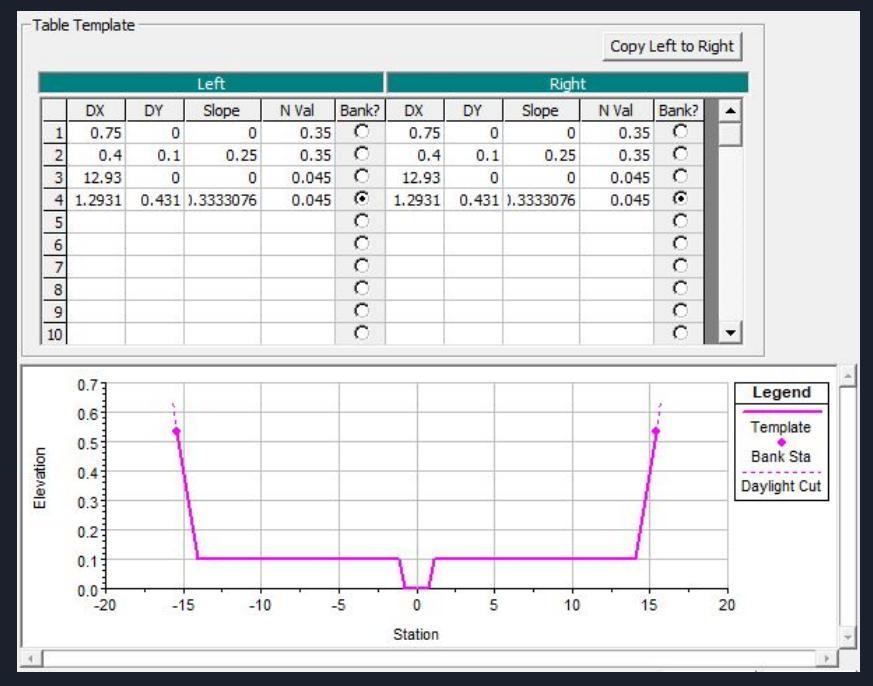
- Utilize bankfull information to find average bankfull in Site 1
- Accommodate average bankfull area determined by previous study (10.95ft<sup>2</sup>)

Fig. 15 - Channel modification template Site 1.

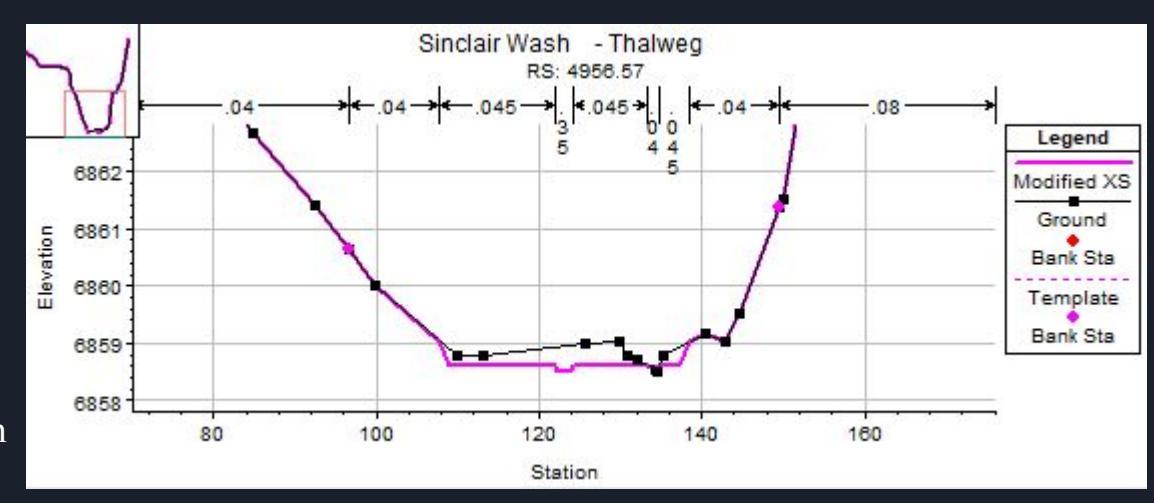
- Implement cross section template to all sections in Site 1
- Change channel center to allow river to meander
- Stabilize banks with slopes of 3H:1V [3]
- Seed channel and banks with City of Flagstaff seeding mix [3]

Fig. 16 - Template cut applied to cross section in Site 1.

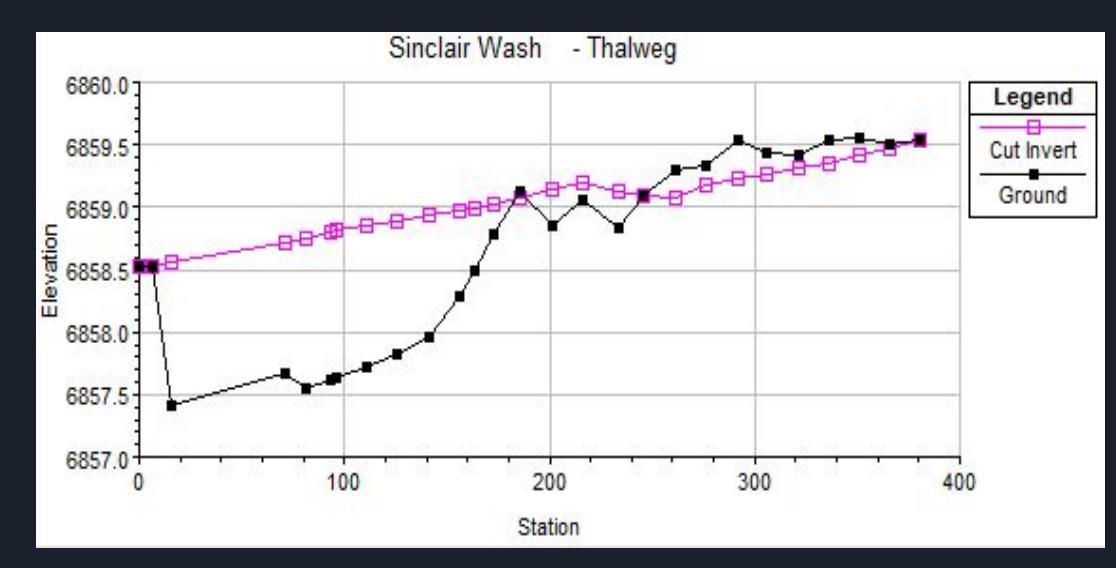
- Implement riffle, run, pool, glide [4]
- Ensure slope connects
   beginning and ending cross
   section
- Install three-sided bridge at site of FUTS crossing
- Install hedge blocking path access to McConnel/Pine Knoll intersection
- Cut: 262  $yd^{3}$
- **♦** Fill: 650 yd<sup>3</sup>

Fig. 17 - Modified channel cross section Site 1.

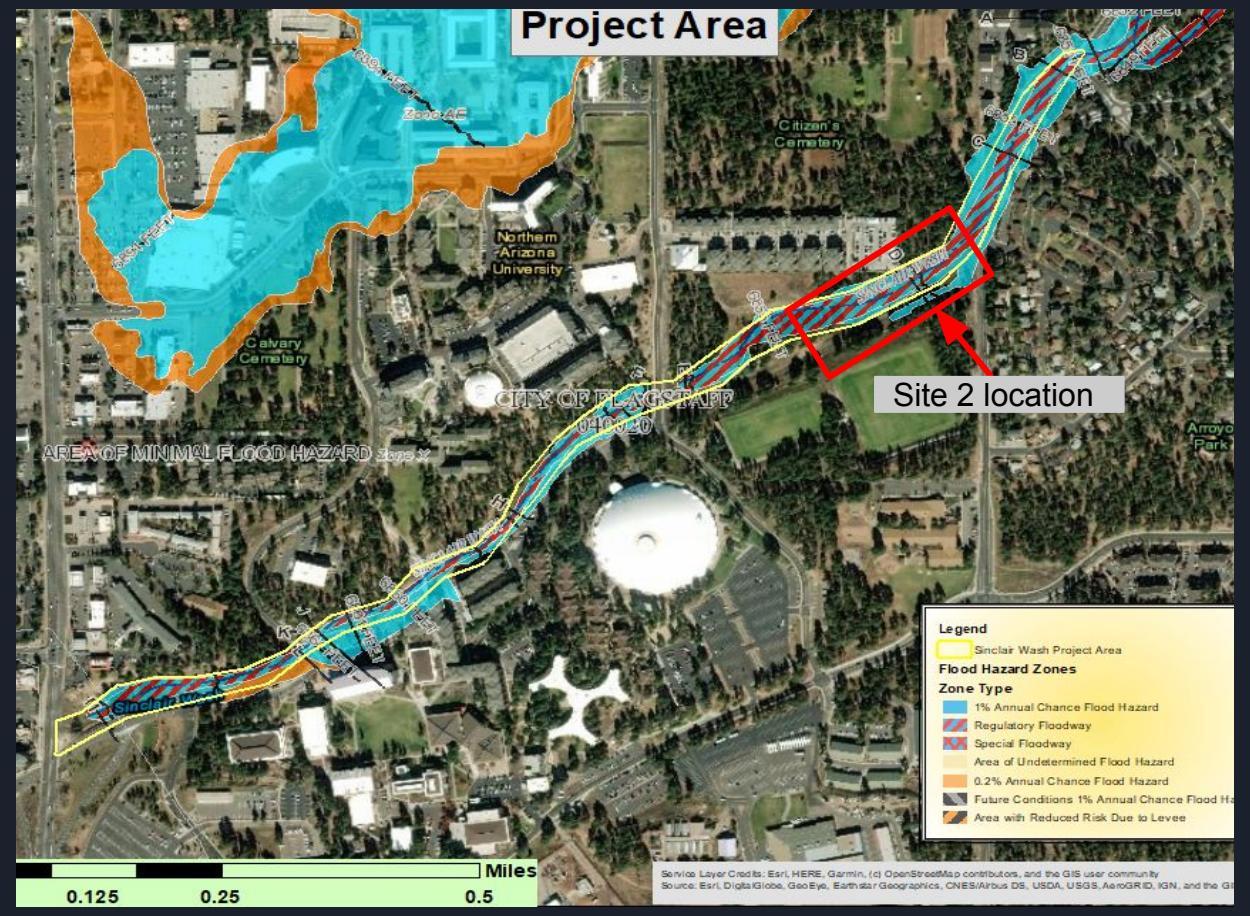
Figure 18. - Overview of Site 2.

- Remove invasive species
- Remove culvert at FUTS trail crossing
- Remove large rocks
   located within the
   channel

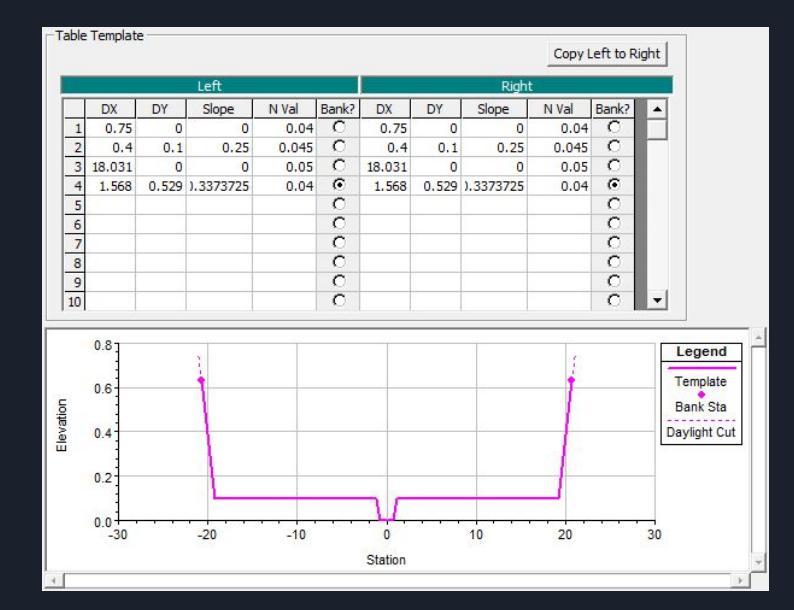
- Utilize bankfull data to determine the average bankfull area of Site 2 [2].
- Accommodate
   bankfull area
   (20.55ft<sup>2</sup>)

Fig. 20 - Channel modification template Site 2.

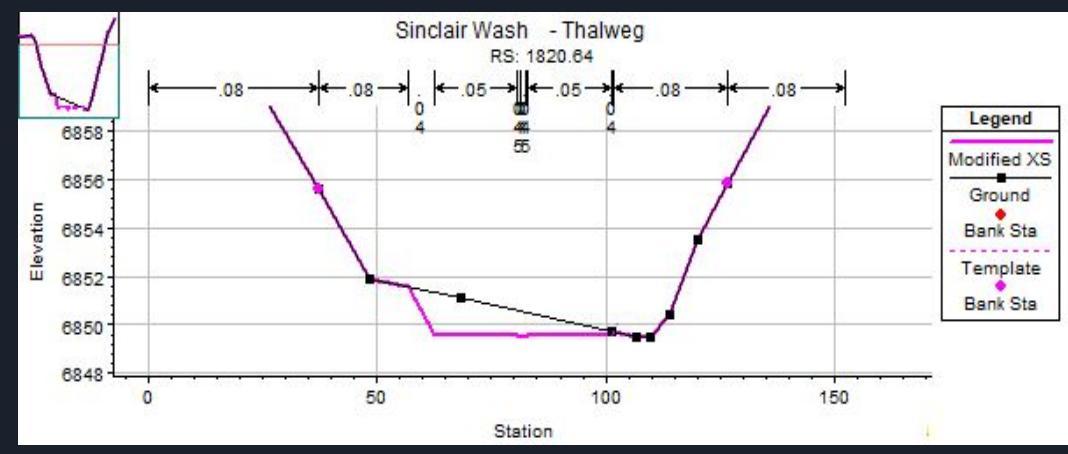
- Implement cross section template to all sections in Site 2
- Seed channel and banks with City of Flagstaff seeding mix [3]
- Stabilize banks greater than
  3:1 slope [3]

Fig. 21 - Modified channel cross section Site 2.

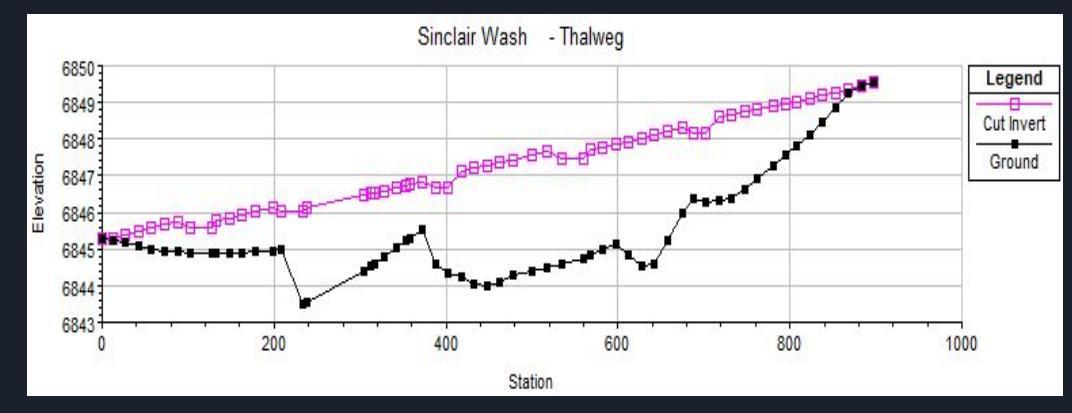
- Implement riffle, run, pool, glide [4].
- Ensure slopes connects beginning and ending cross section
- Alter direction of
   Flagstaff Urban Trail to
   not cross channel
- Cut: 541 yd<sup>3</sup>
- ✤ Fill: 6544 yd<sup>3</sup>

Fig. 22 - Proposed channel slope Site 2.

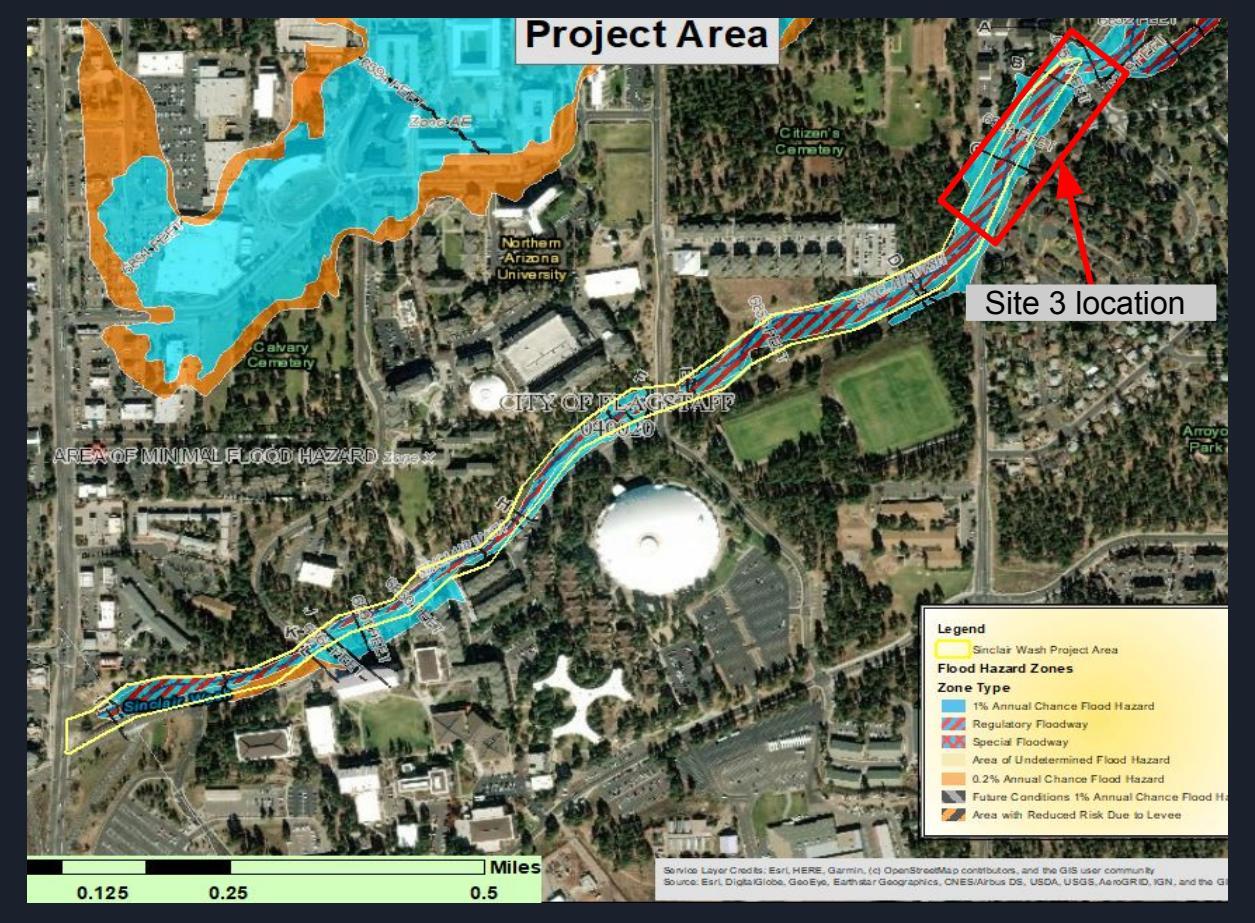
Fig. 23 - Overview of Site 3.

- Remove invasive
   species found in the
   area
- Remove large deposits of gravel and rocks

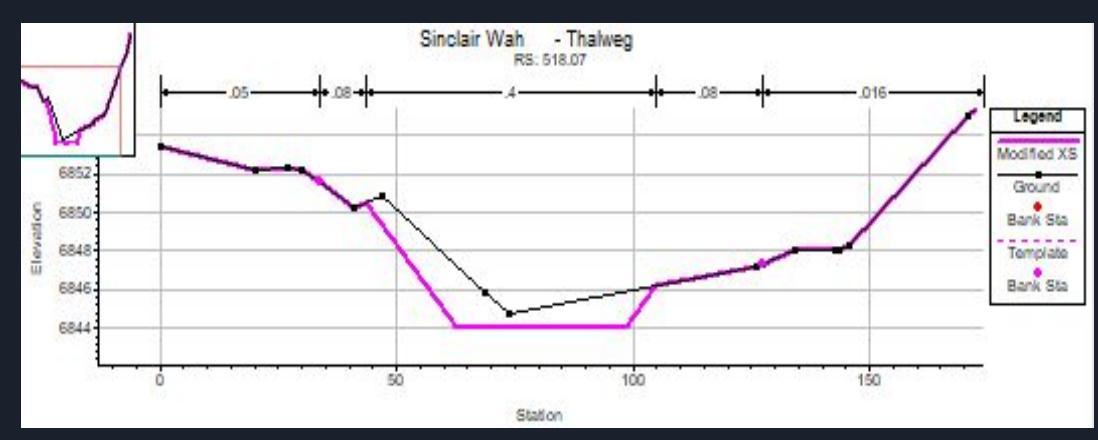
- Apply template to all cross sections
- Apply cuts in a way for channel to meander
- Stabilize banks with greater than 3:1 slope [3]
- Seed channel and banks with City of Flagstaff seeding mix [3].

Fig. 26 - Modified channel cross section Site 3.

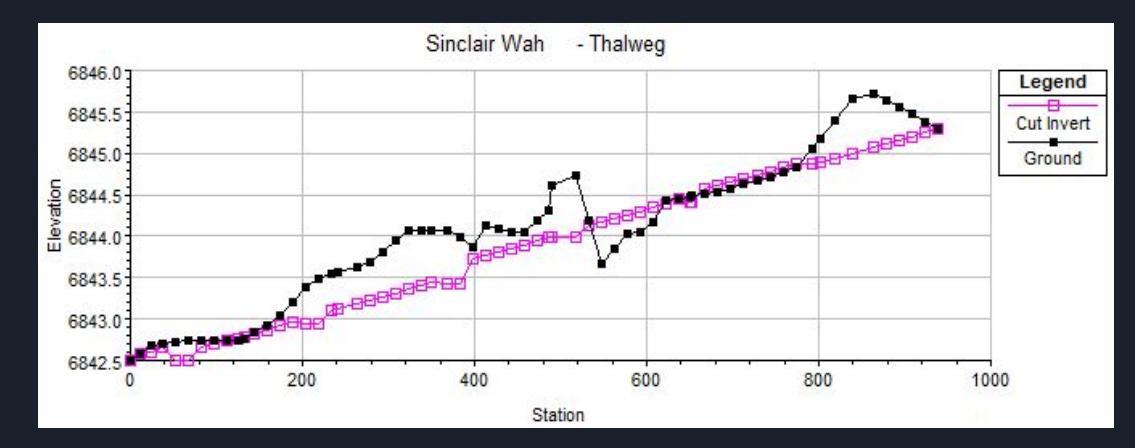
- Implement riffle, run, pool, glide [4].
- Ensure slope lines up with beginning and ending cross section
- Cut:  $4327 \text{ yd}^3$
- Fill: 709  $yd^3$

Fig. 27 - Proposed channel slope Site 3.

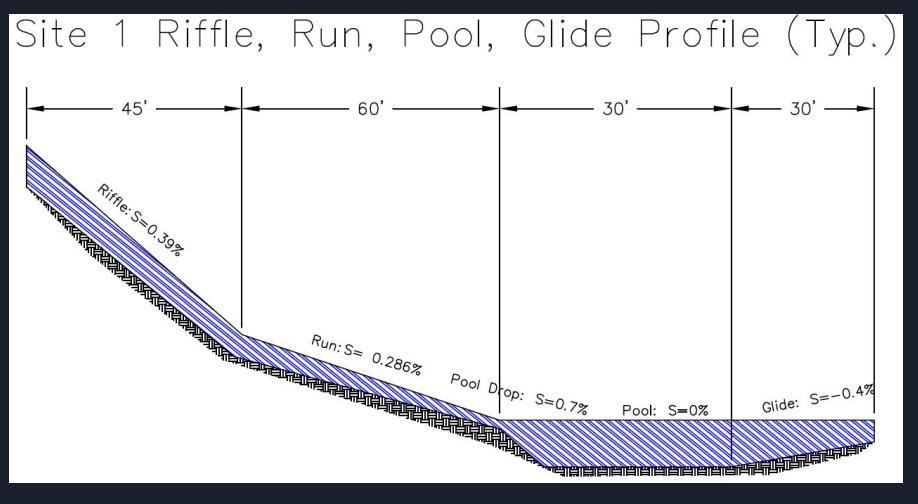
Fig. 29 - Typical Riffle, Run, Pool, Glide detail for Site 1.

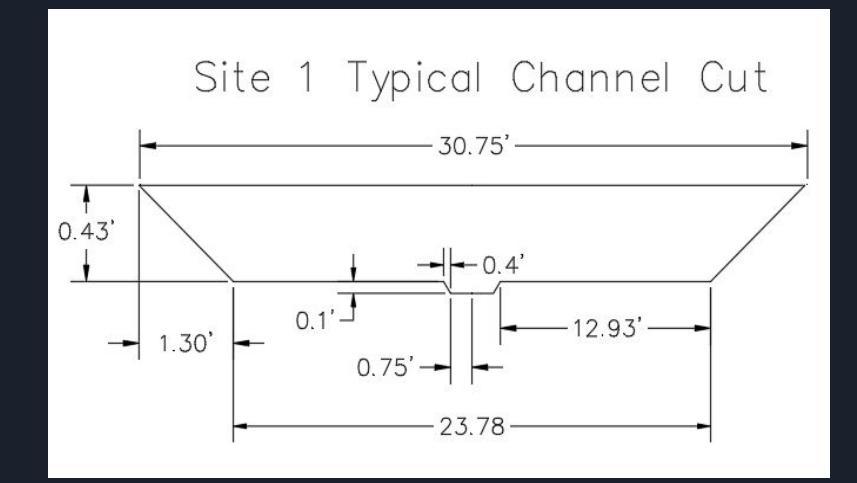
Fig. 30 - Typical Channel Cut detail for Site 1
